Converted Canal Barge
“Rose”

Structural Survey

Report Reference: RT-H190327

27th March 2019

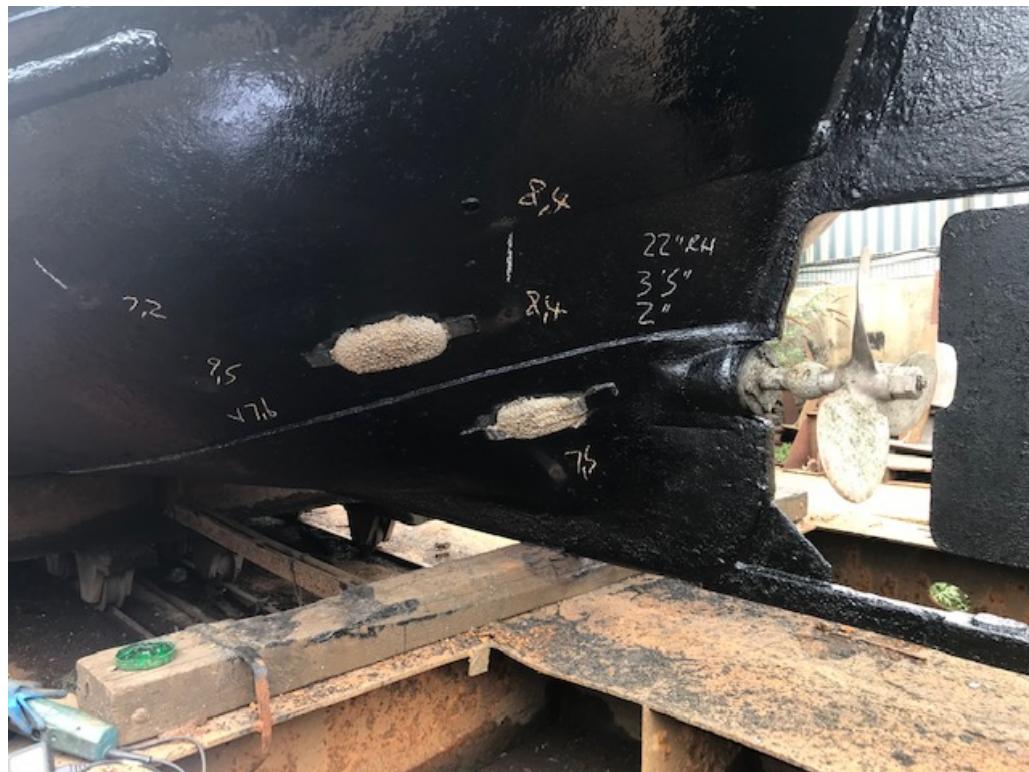
The three bladed right handed 22" propeller was in good condition, true to the eye when rotated by hand. With no undue distortion or corrosion noted, the propeller was well secured to the shaft with two nuts and split-pin.

The 2" stainless steel drive shaft was also in good order with only minor free play noted on the outer bearing.
